Case 413 : Narrative

Case Vehicle (A): 2002 Chevrolet	Vehicle (B): 2004 Cadillac
Type: Silverado 1500 Z71, 4x4, 4-door pickup	Type: SRX, 4-door SUV
Driver: 32-year-old female	Driver: 45-year-old male
CDC: 12-FLAE-9	CDC: 99-9999-0

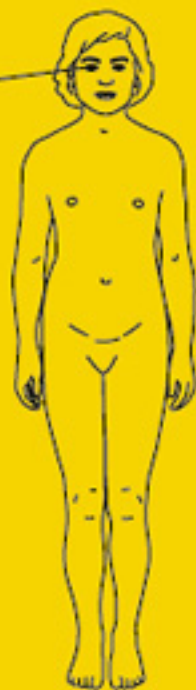
Occupant: Driver	Age: 32 years	Gender: Female		
Restraints: 3-point belt; steering-wheel airbag	Stature: 163 cm (5 ft, 4 in)	Mass: 66 kg (145 lb)		
Injury Description	A.I.S.	Injury Source		
—	—	Definite	Probable	Possible
Abrasion, left eyebrow	1	—	Broken glass from driver door	—
Contusion, right posterior basal aspect of head	1	—	—	Head restraint
Contusions, across the chest	1	—	Shoulder belt	—
Contusion, left wrist	1	—	—	Airbag
Contusion, right wrist	1	—	—	Airbag
Contusion, left elbow	1	—	Door interior	—
Laceration, left elbow	1	—	Door interior	—
Contusion, left hip	1	—	Lap belt	—
Contusion, right hip	1	—	Lap belt	—
Contusion, left knee	1	Knee bolster	—	—
Contusion, right knee	1	Knee bolster	—	—

Contusion, left calf	1	—	—	Seat cushion
Contusion, distal aspect of right leg	1	—	—	Floor-mounted console
Contusion, left ankle	1	—	—	Kickpanel
Contusion, left foot	1	—	—	Kickpanel
Ruptured ligament, left ankle	2	—	—	Toepan, bracing
Maximum A.I.S. Level	2	—	—	—
Injury Severity Score	5	—	—	—

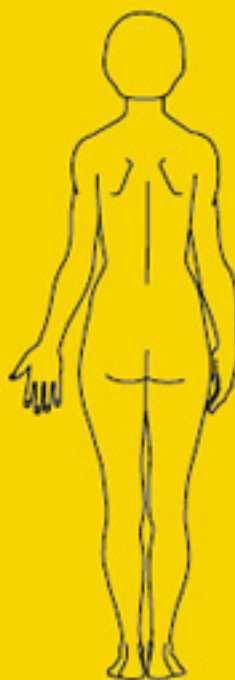
Occupant: Right front	Age: 9 years	Gender: Female		
Restraints: 3-point belt; dash-mounted airbag	Stature: 119 cm (3 ft, 11 in)	Mass: 25 kg (54 lb)		
Injury Description	A.I.S.	Injury Source		
—	—	Definite	Probable	Possible
Contusion, around right eye	1	—	Airbag	—
Maximum A.I.S. Level	1	—	—	—
Injury Severity Score	1	—	—	—

Contusion, around
right eye
(1)
